## Wendell Wetland Services

Re: Restoration of Impacted Wetlands and Buffer Zone,  
West Leyden Road

### Wetland Delineation and Survey

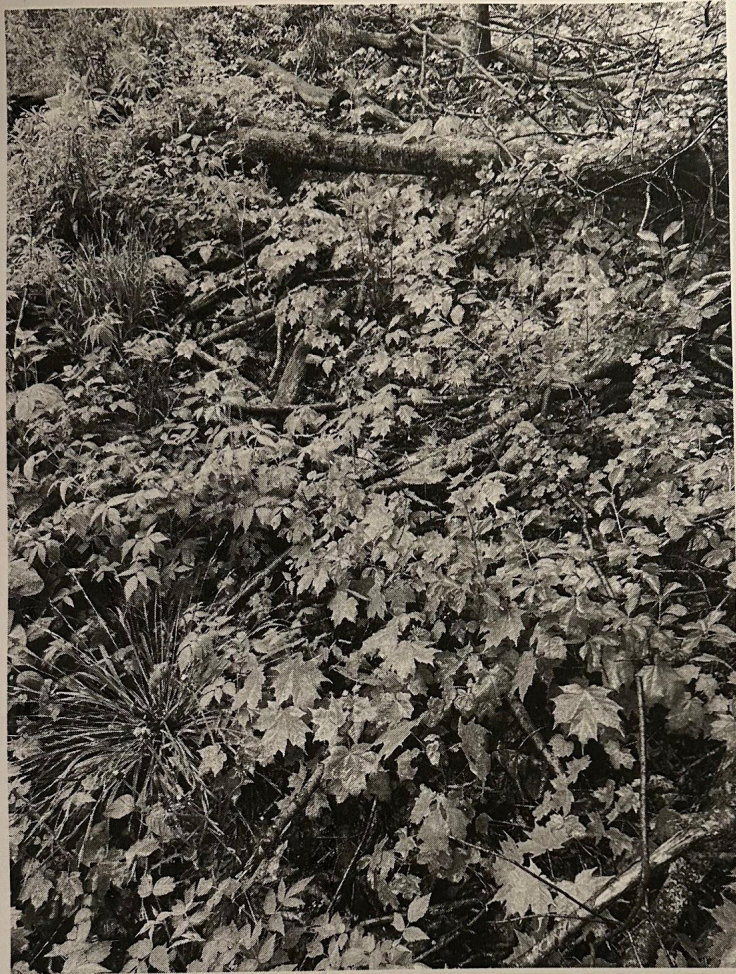
Photo 3: Maple Seedlings in Logged Buffer Zone

The logging road crosses the buffer zone on both sides of the intermittent stream and wetland crossing. Fortunately, herbaceous plants have quickly become established on the logging road, which has stabilized the soils. Tree cutting occurred on almost an acre of buffer zone, although much of this area was not clear-cut (see photo 2). In addition, there are numerous maple seedlings growing in the buffer zone (see photo 3). The limit of work line has been marked by signage (see photo 4).
